MINNESOTA STATE OFFICE BUILDING

ISSUES AND VULNERABILITIES

State Office Building Facility Condition Assessment

MINNESOTA STATE OFFICE BUILDING ISSUES AND VULNERABILITIES

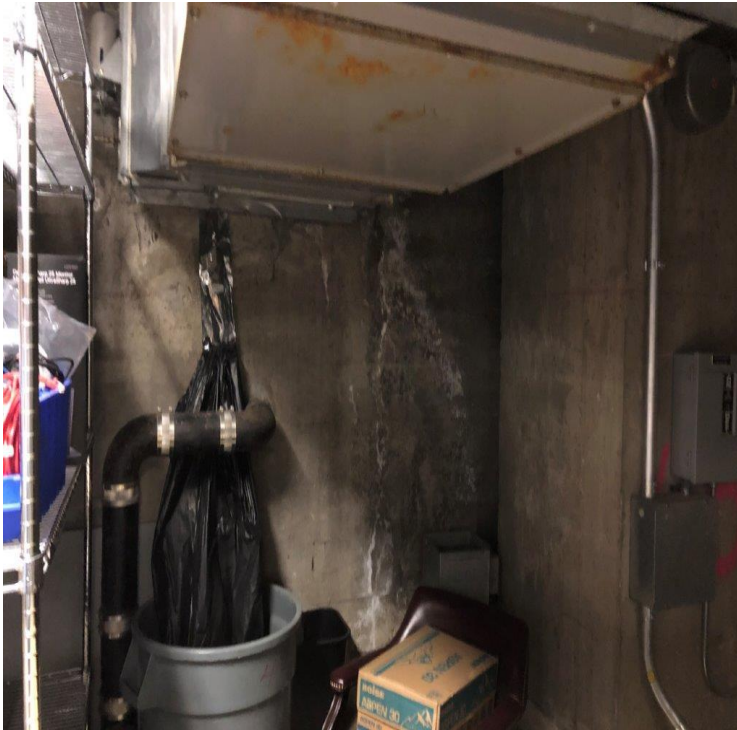
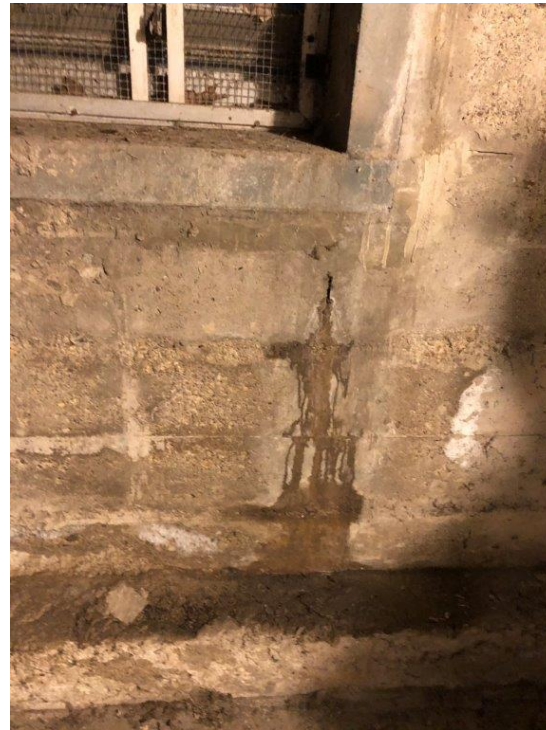
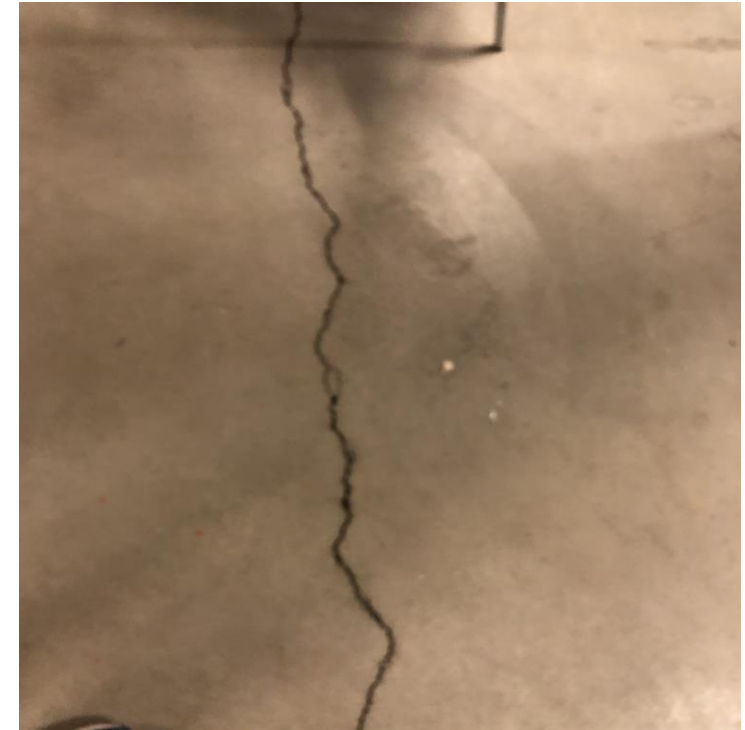
Slab & Basement Walls

Fair

Stress Cracks, Leakage

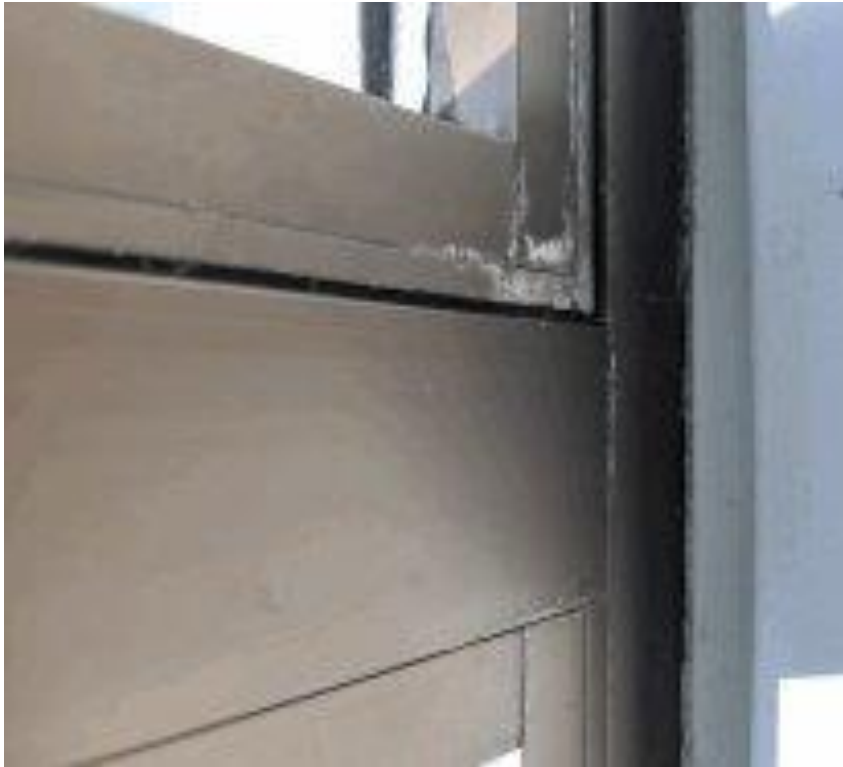
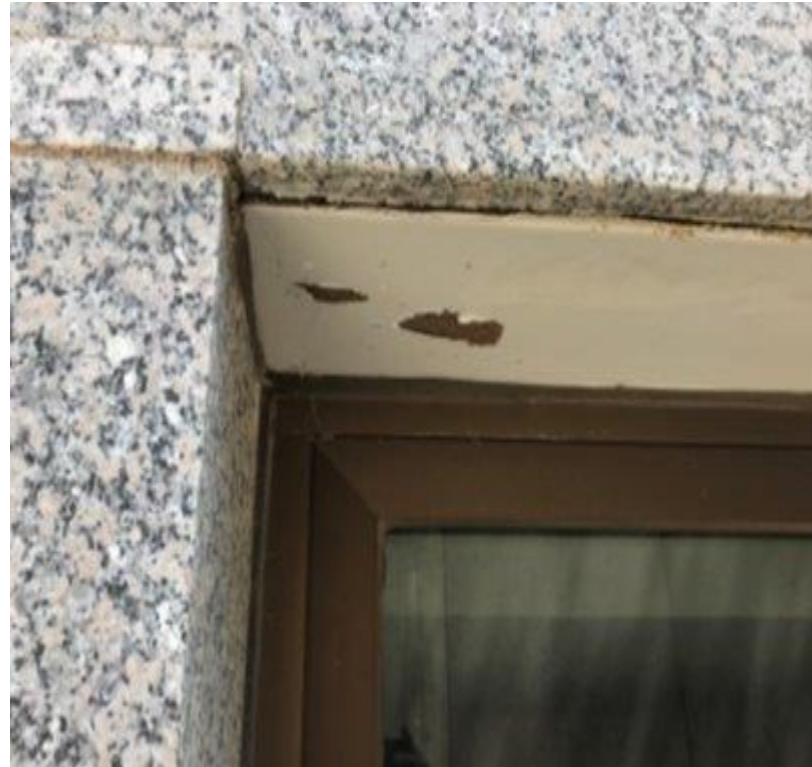
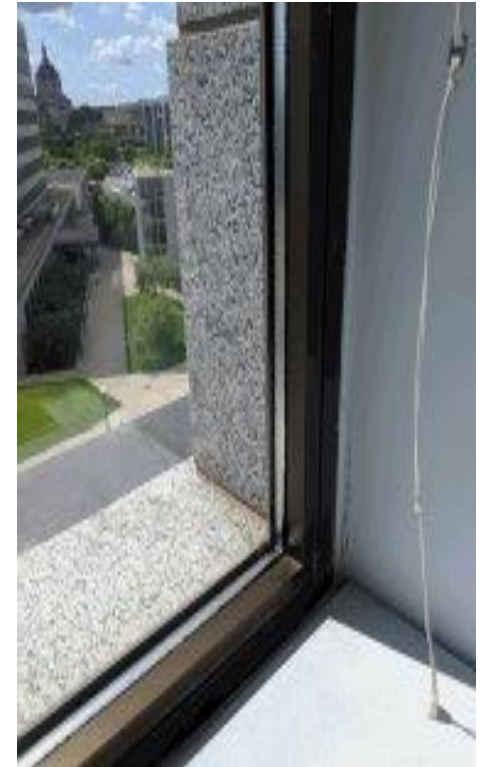
Exterior Windows

Poor

Age, Lintels Corroding, Thermal Breaks Failing, Energy Inefficient

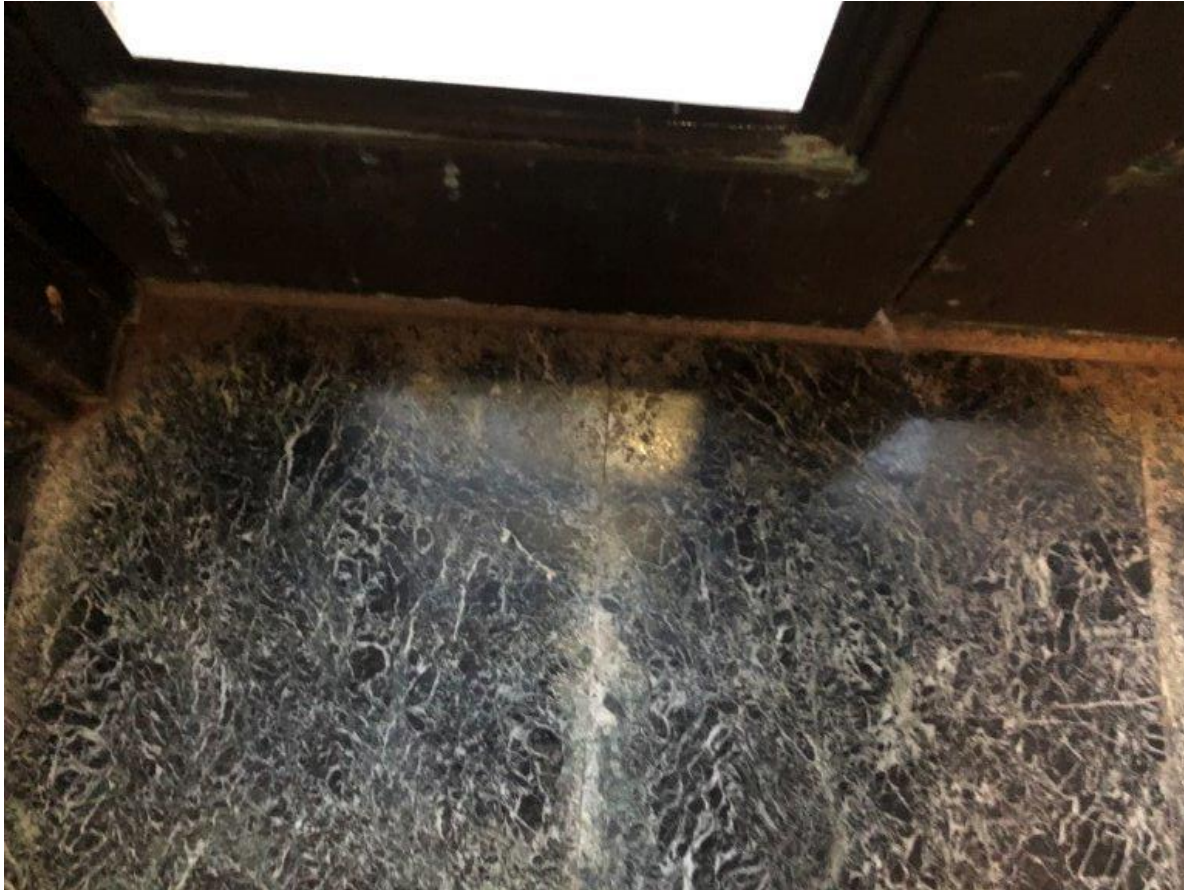
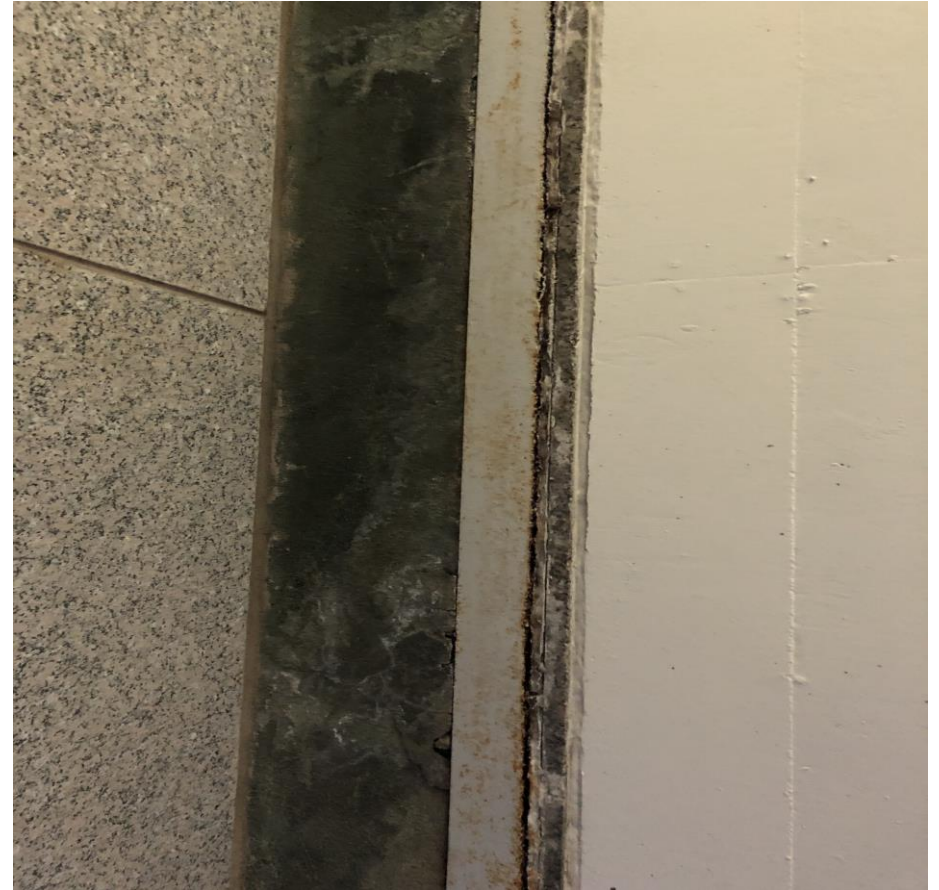
Exterior Doors

Fair

Age, Seals Failing, Frames Rusting, Energy Inefficient

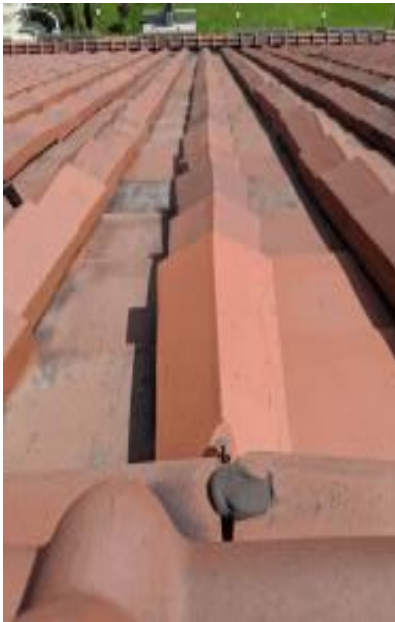
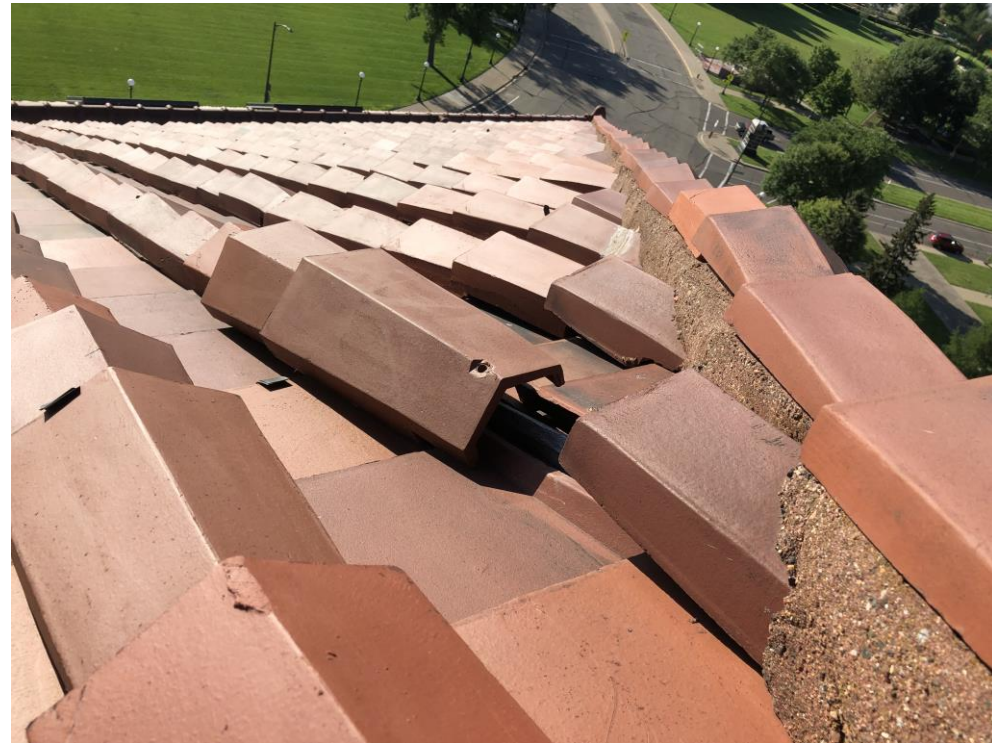
Roof Covering (Includes Drainage System)

Poor

Overall Age of Roofing System, Areas of Cracked Terra Cotta Tile, Missing Nails, Leaks in Various Locations, Roof Trusses and Joists Structurally Sound

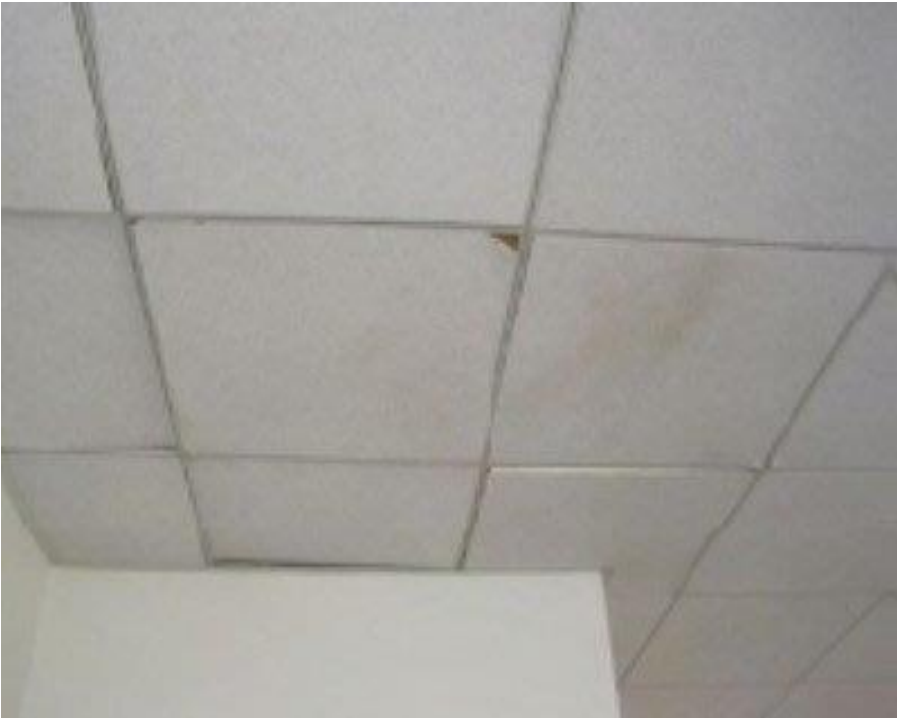
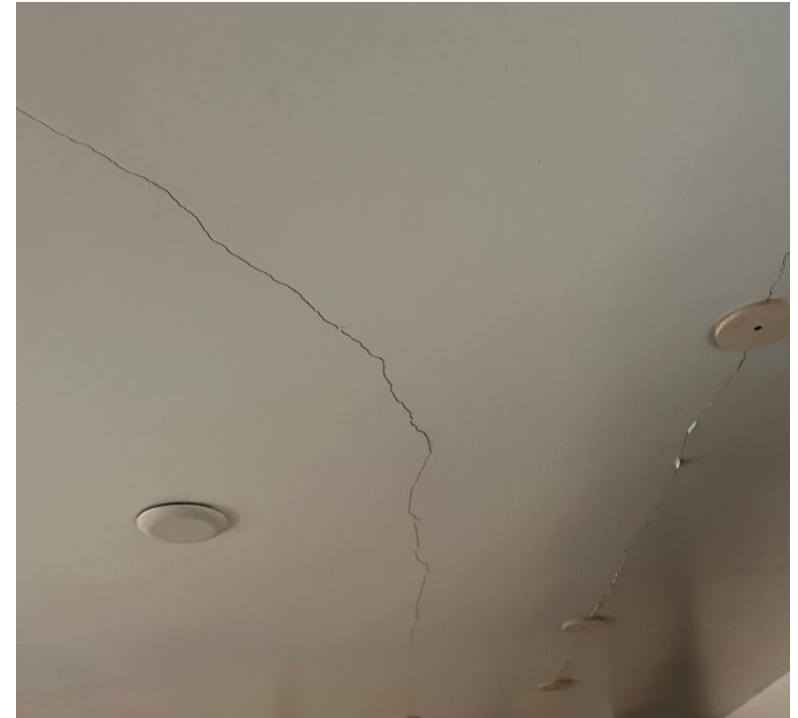
Ceilings

Fair

Age, Stains, Grime, Cracks

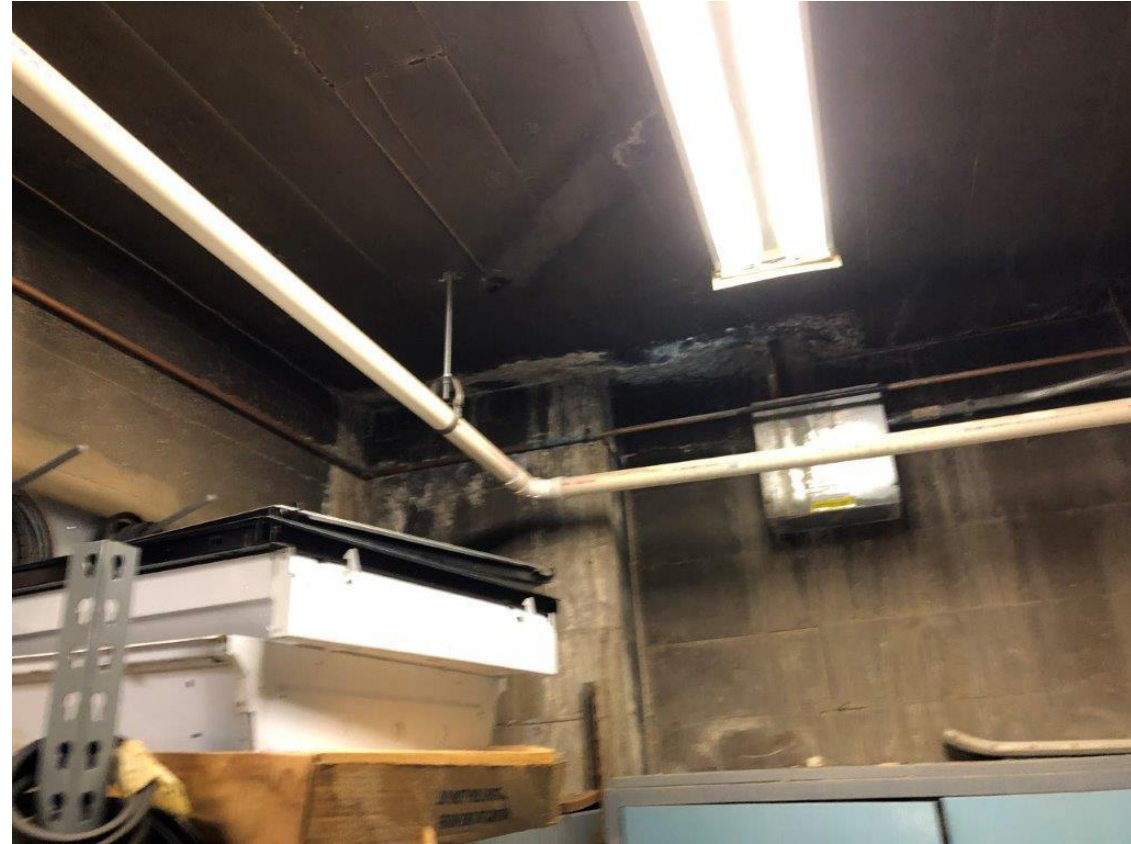
Plumbing Systems (Water & Sewer)

Poor

Age, Build-up in Waste Piping, Inadequate Slope for Low Flow Fixtures, Insufficient Valving

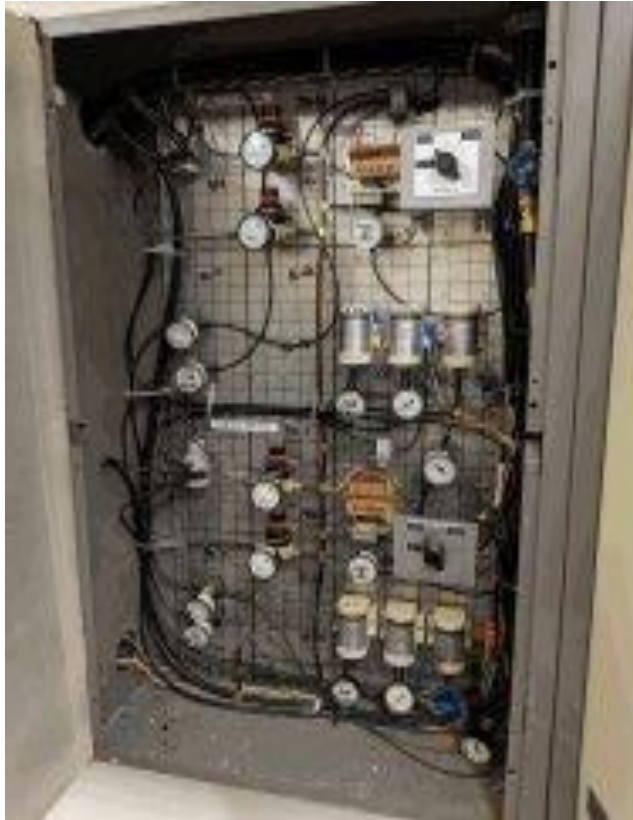
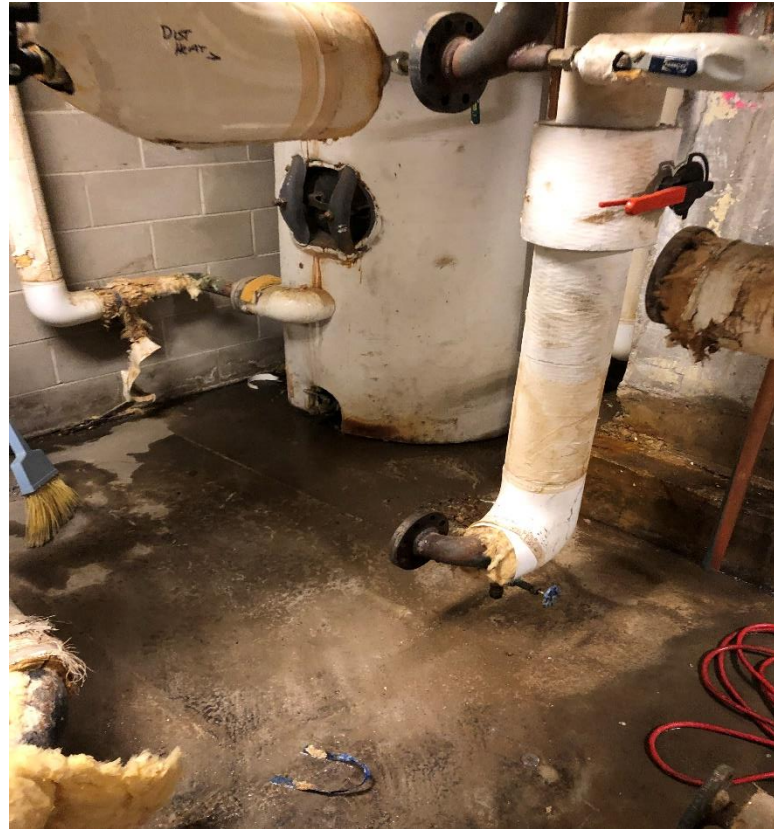
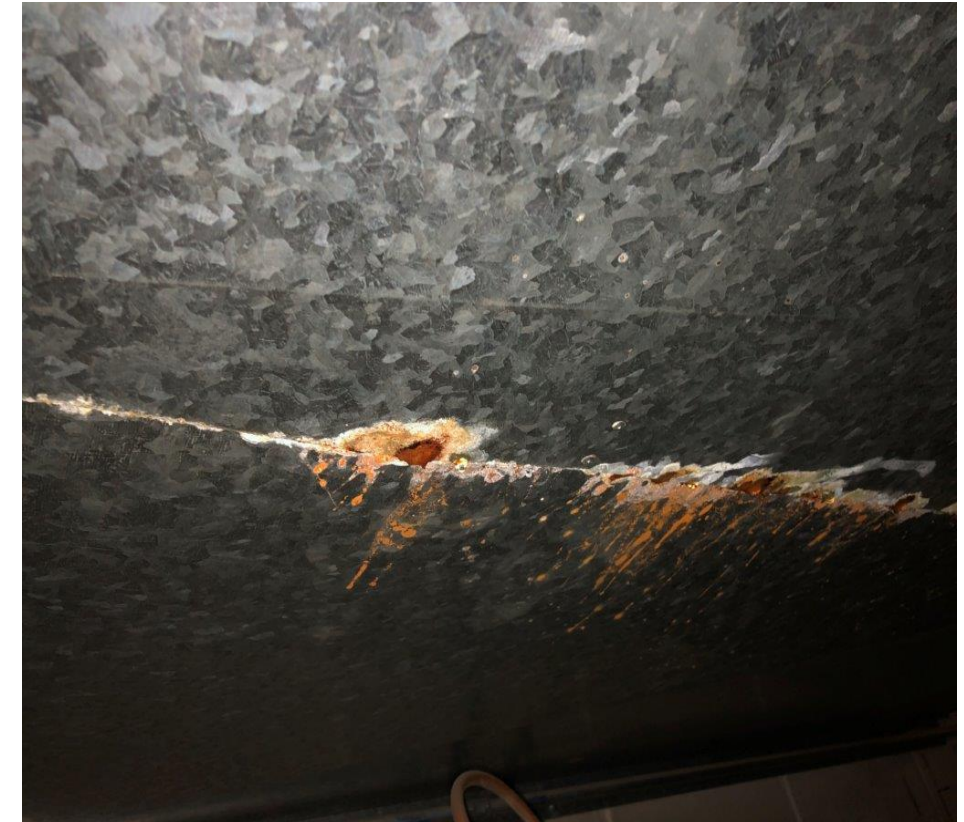
HVAC System (Controls & Distribution)

Poor

Piecemeal, Pneumatically Controlled, Pipe Connections Failing, Difficult to Maintain Constant Temps, Threat of Leaks

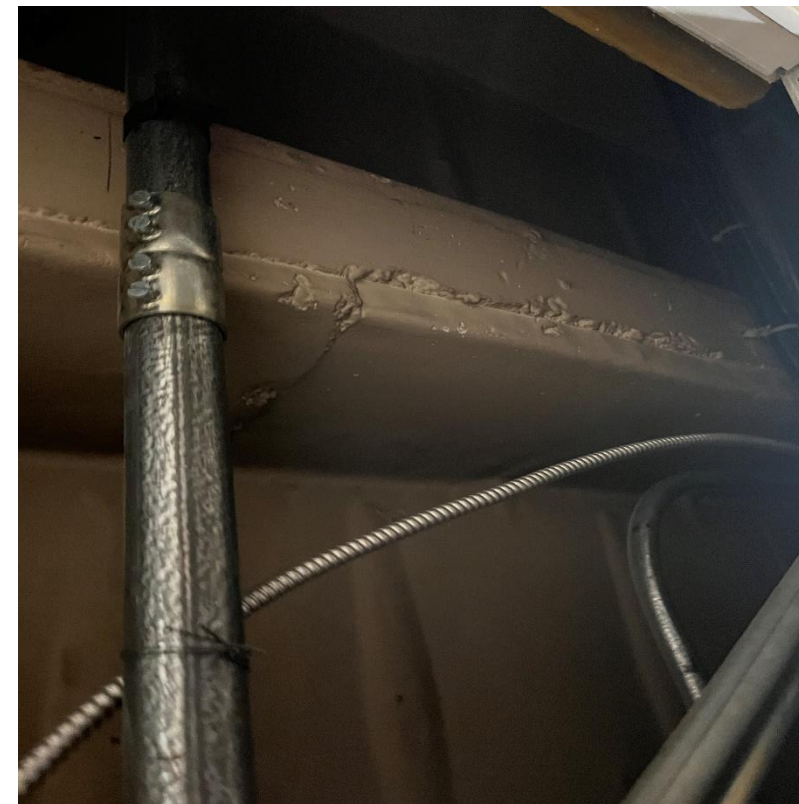
Electrical Systems & Lighting

Fair

Old, Undersized System, and Inefficient Lighting

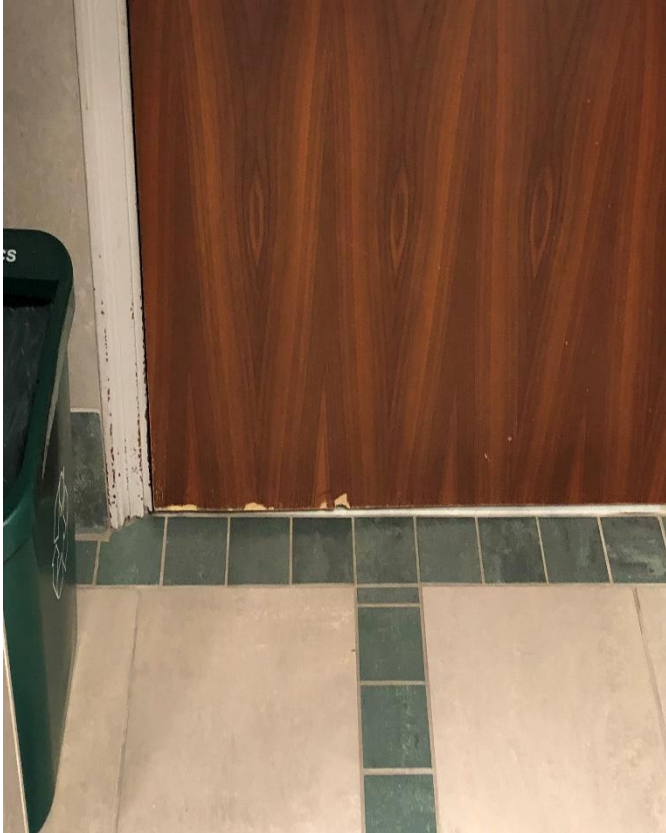
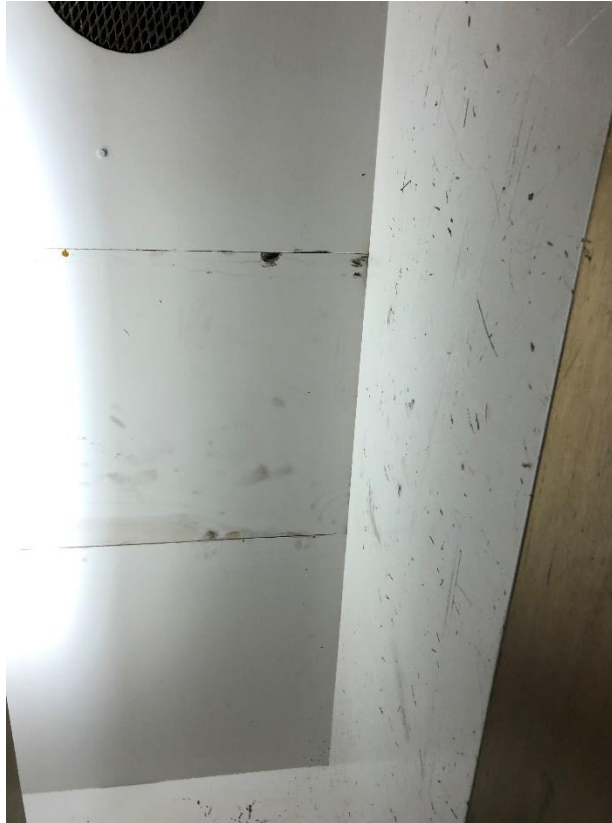
Interior Finishes

Fair

Age, Wear and Tear

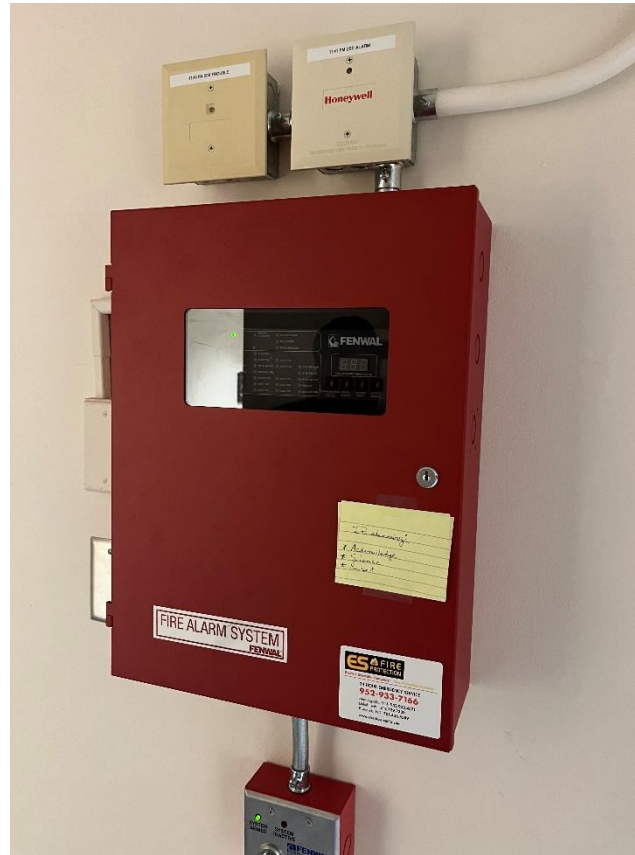
Fire Alarm System

Fair

Wiring and Field Devices Nearly 40 Years Old and Need Replacement

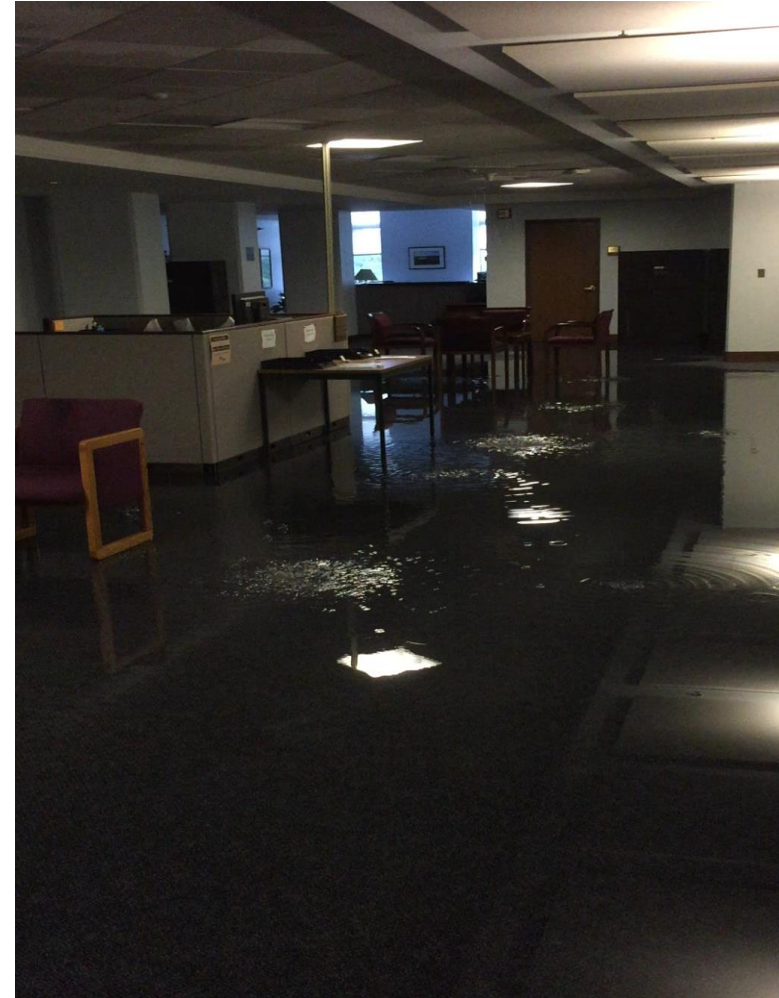
JUNE 2016

Broken element of the HVAC system resulted in flooding on six floors and required extensive remediation and repair.

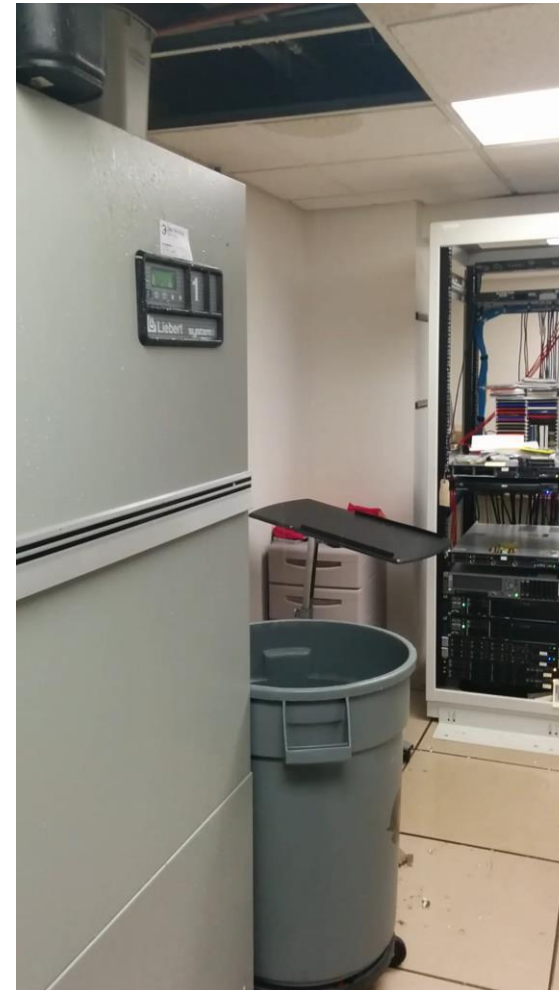
JUNE 2016

Broken element of the HVAC system resulted in flooding on six floors and required extensive remediation and repair.

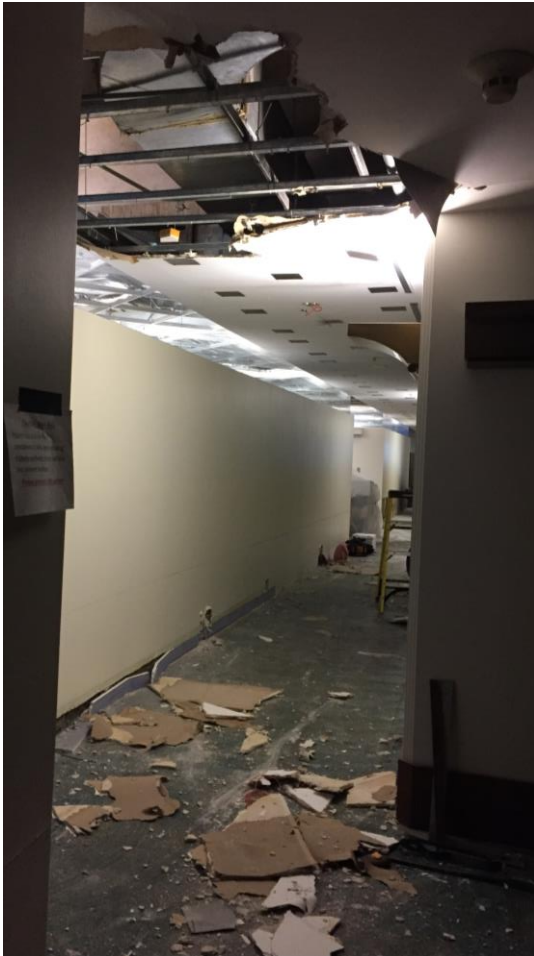
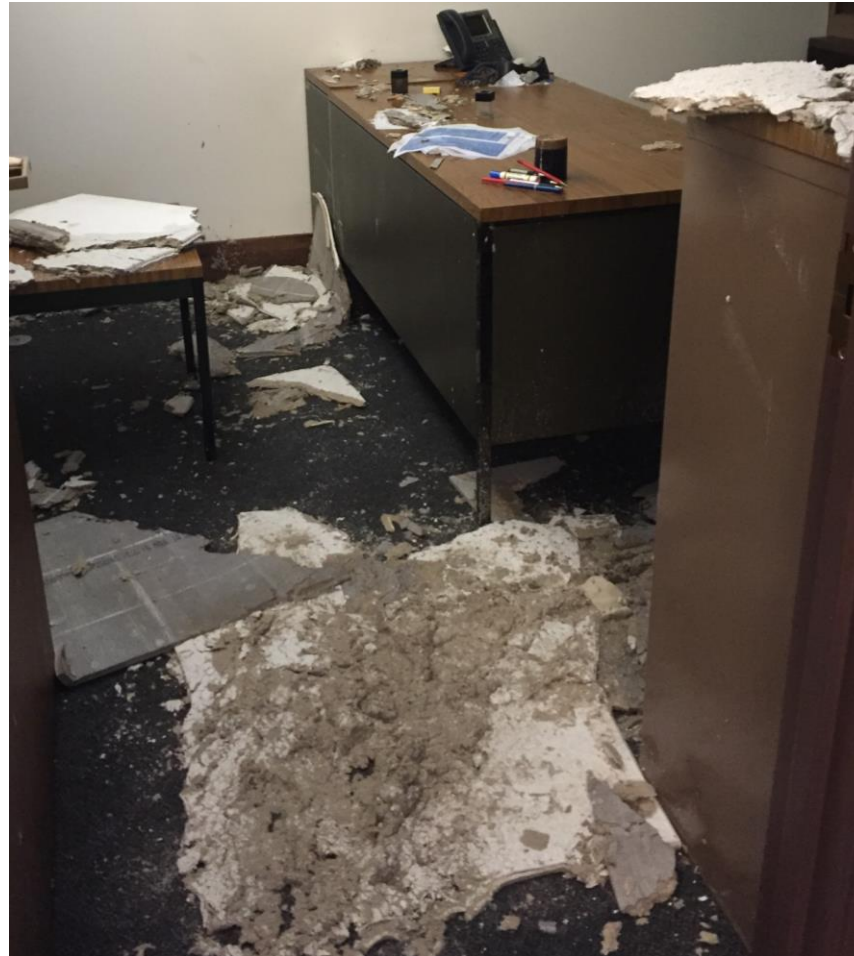
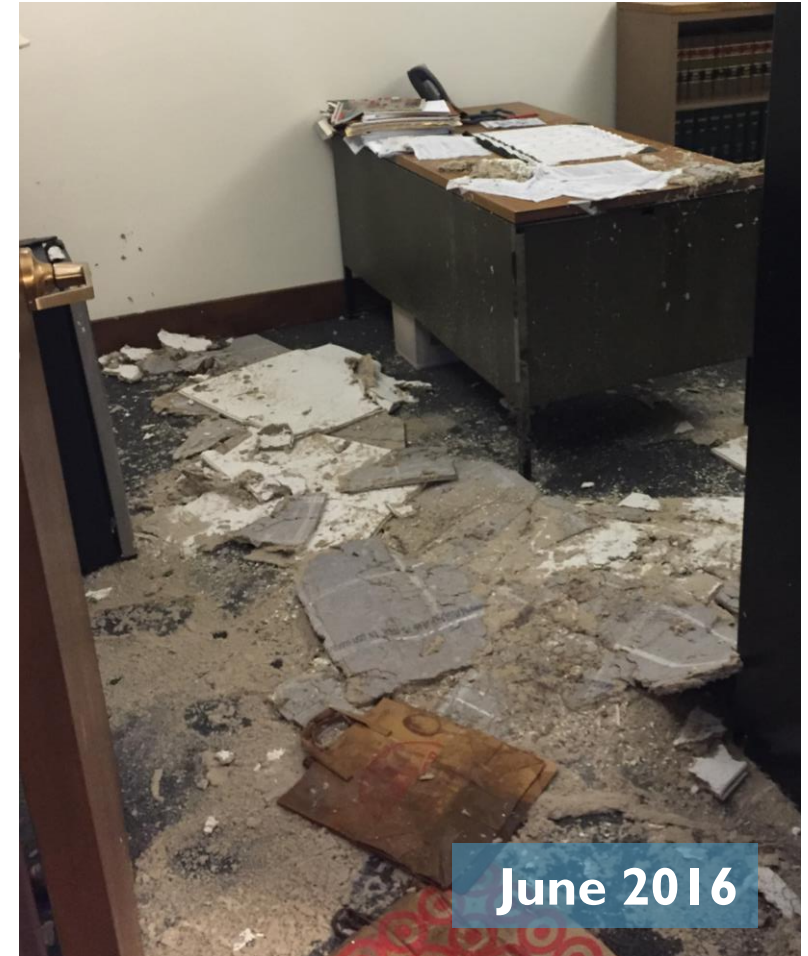
June 2016

OUTDATED INFRASTRUCTURE MAJOR WATER INFILTRATION

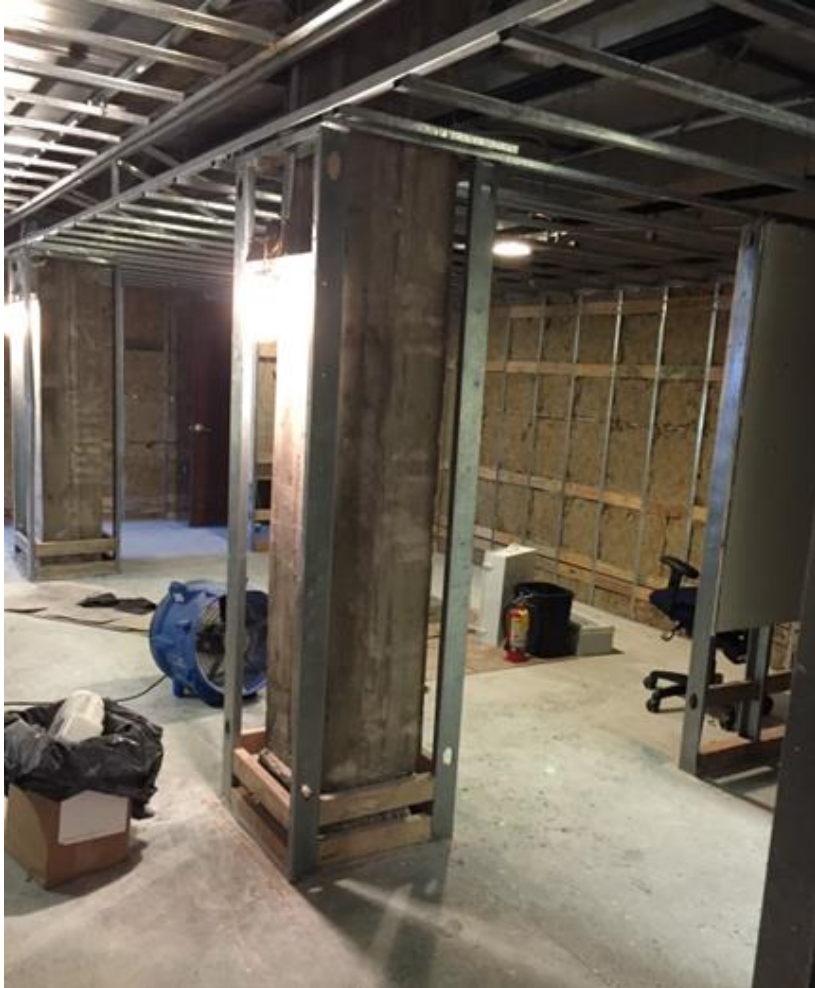
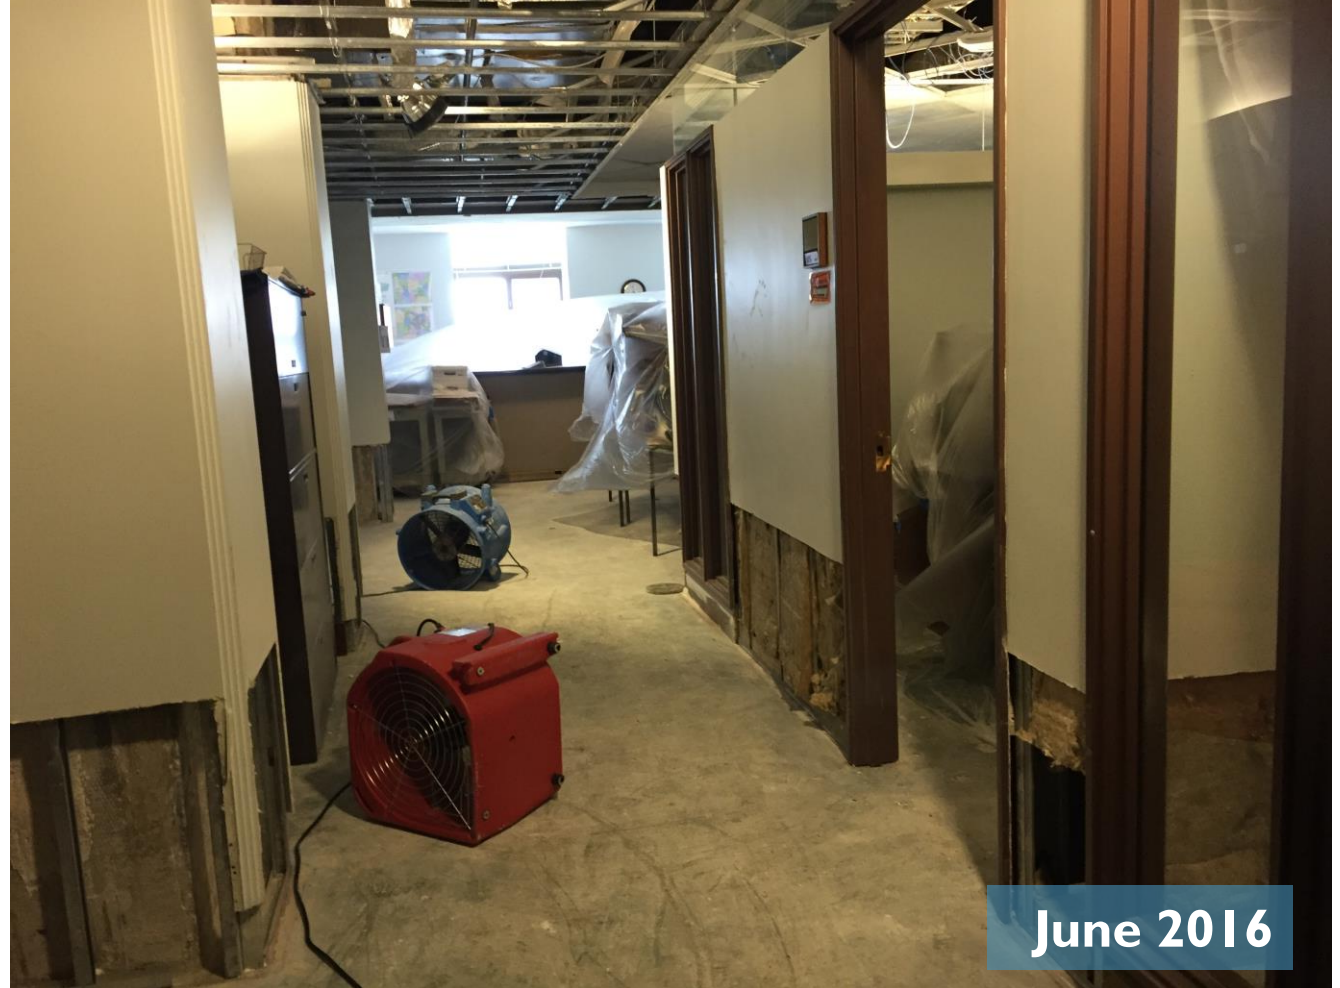
June 2016

OUTDATED INFRASTRUCTURE MAJOR WATER INFILTRATION

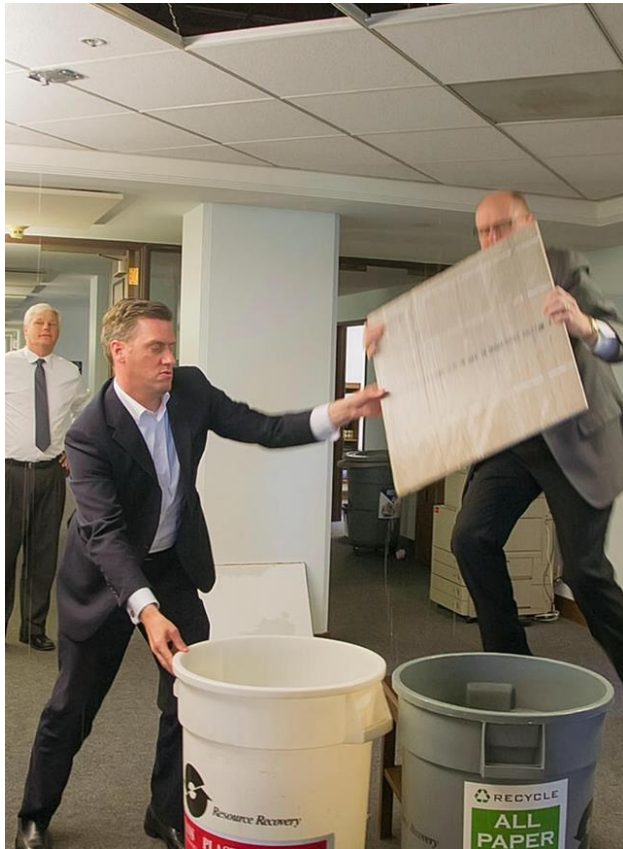
March 2016

OTHER EXAMPLES OF MOISTURE INTRUSION

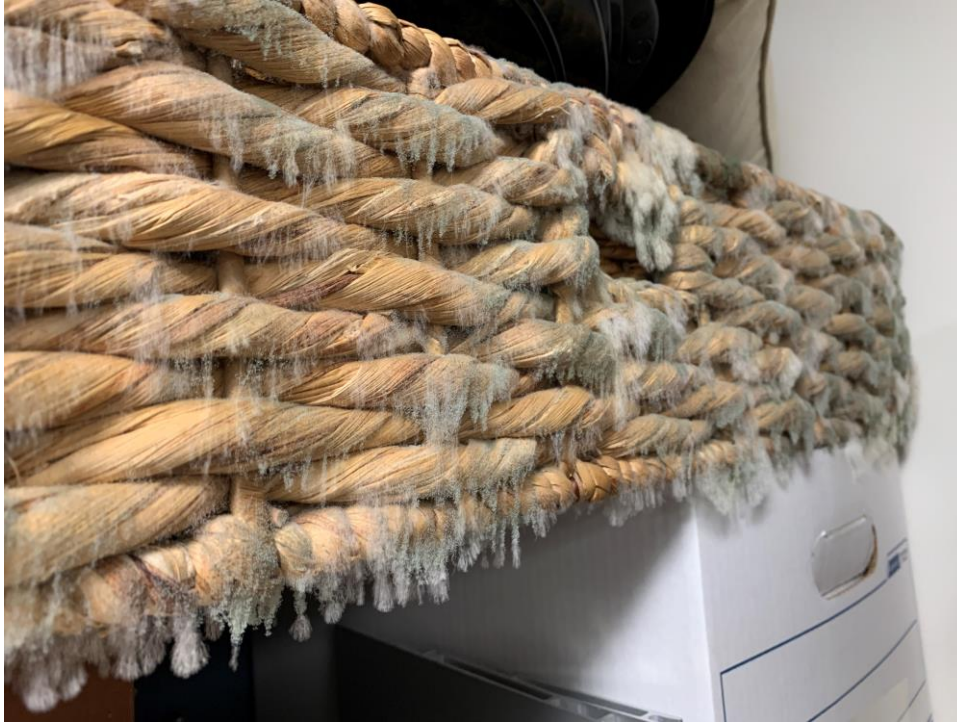
Mold growth in a basement area converted and used as staff office space with inadequate ventilation and high humidity levels

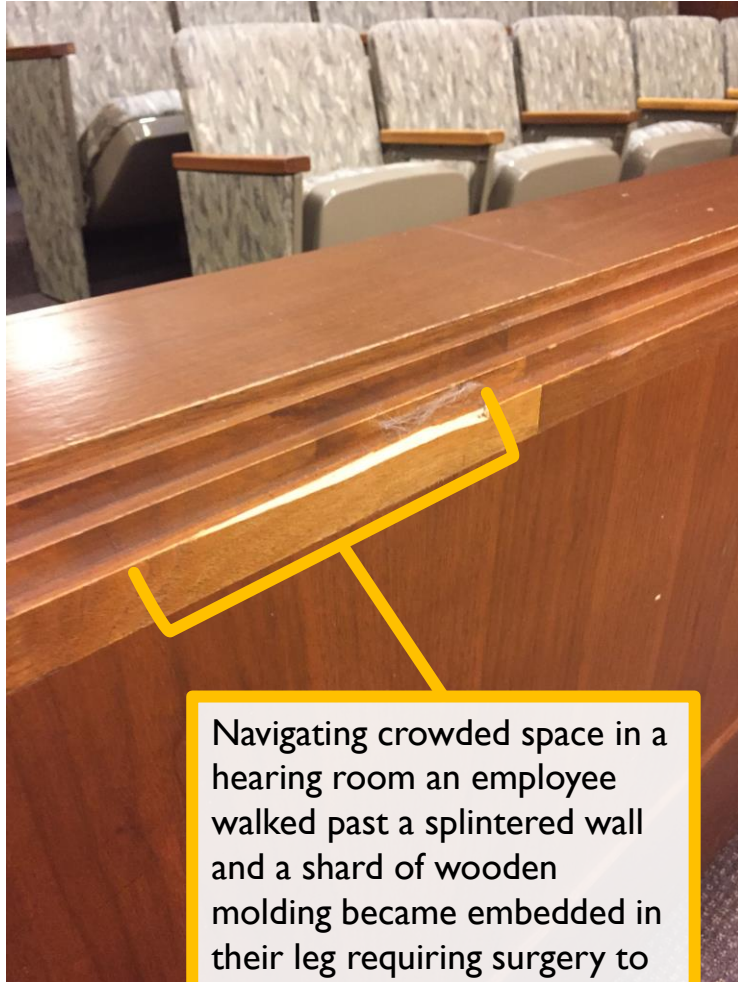
Navigating crowded space in a hearing room an employee walked past a splintered wall and a shard of wooden molding became embedded in their leg requiring surgery to remove.

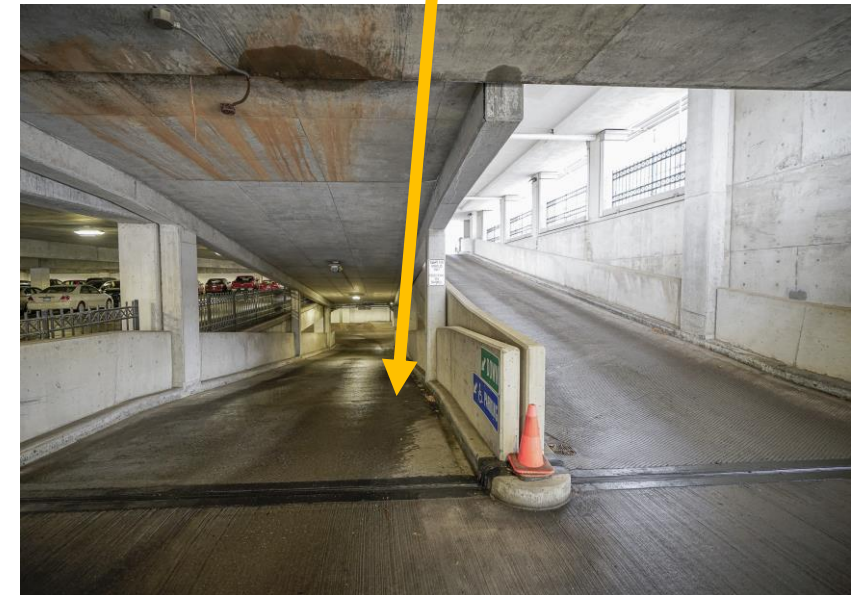
Inadequate pedestrian pathways in ramp have encouraged pedestrian use of vehicular ramp, resulting in falls and injury

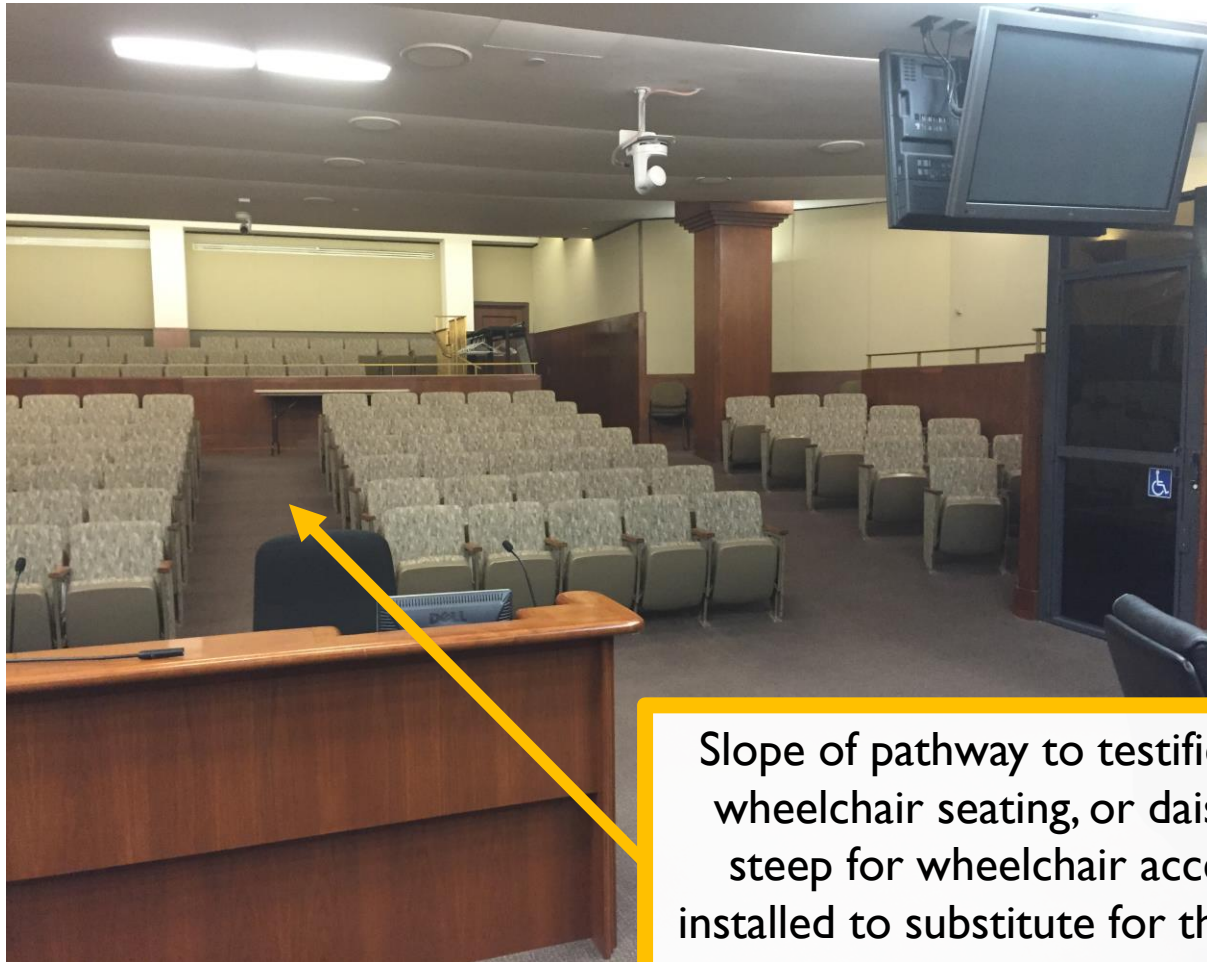
Slope of pathway to testifier table, wheelchair seating, or dais is too steep for wheelchair access; lift installed to substitute for the path is disruptive when operated

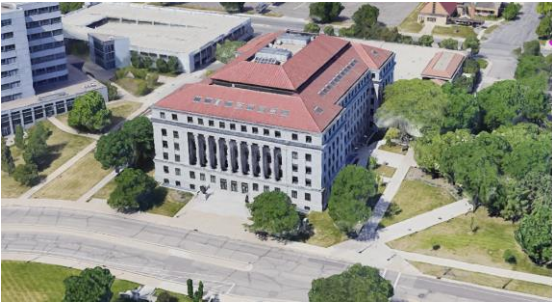
INADEQUATE BUILDING APPROACHES

Only public vehicle access at grade is on the South side of the building

At the South side, designated areas for critical functions overlap:
