MINNESOTA STATE OFFICE BUILDING

ISSUES AND VULNERABILITIES

State Office Building Facility Condition Assessment

MINNESOTA STATE OFFICE BUILDING ISSUES AND VULNERABILITIES

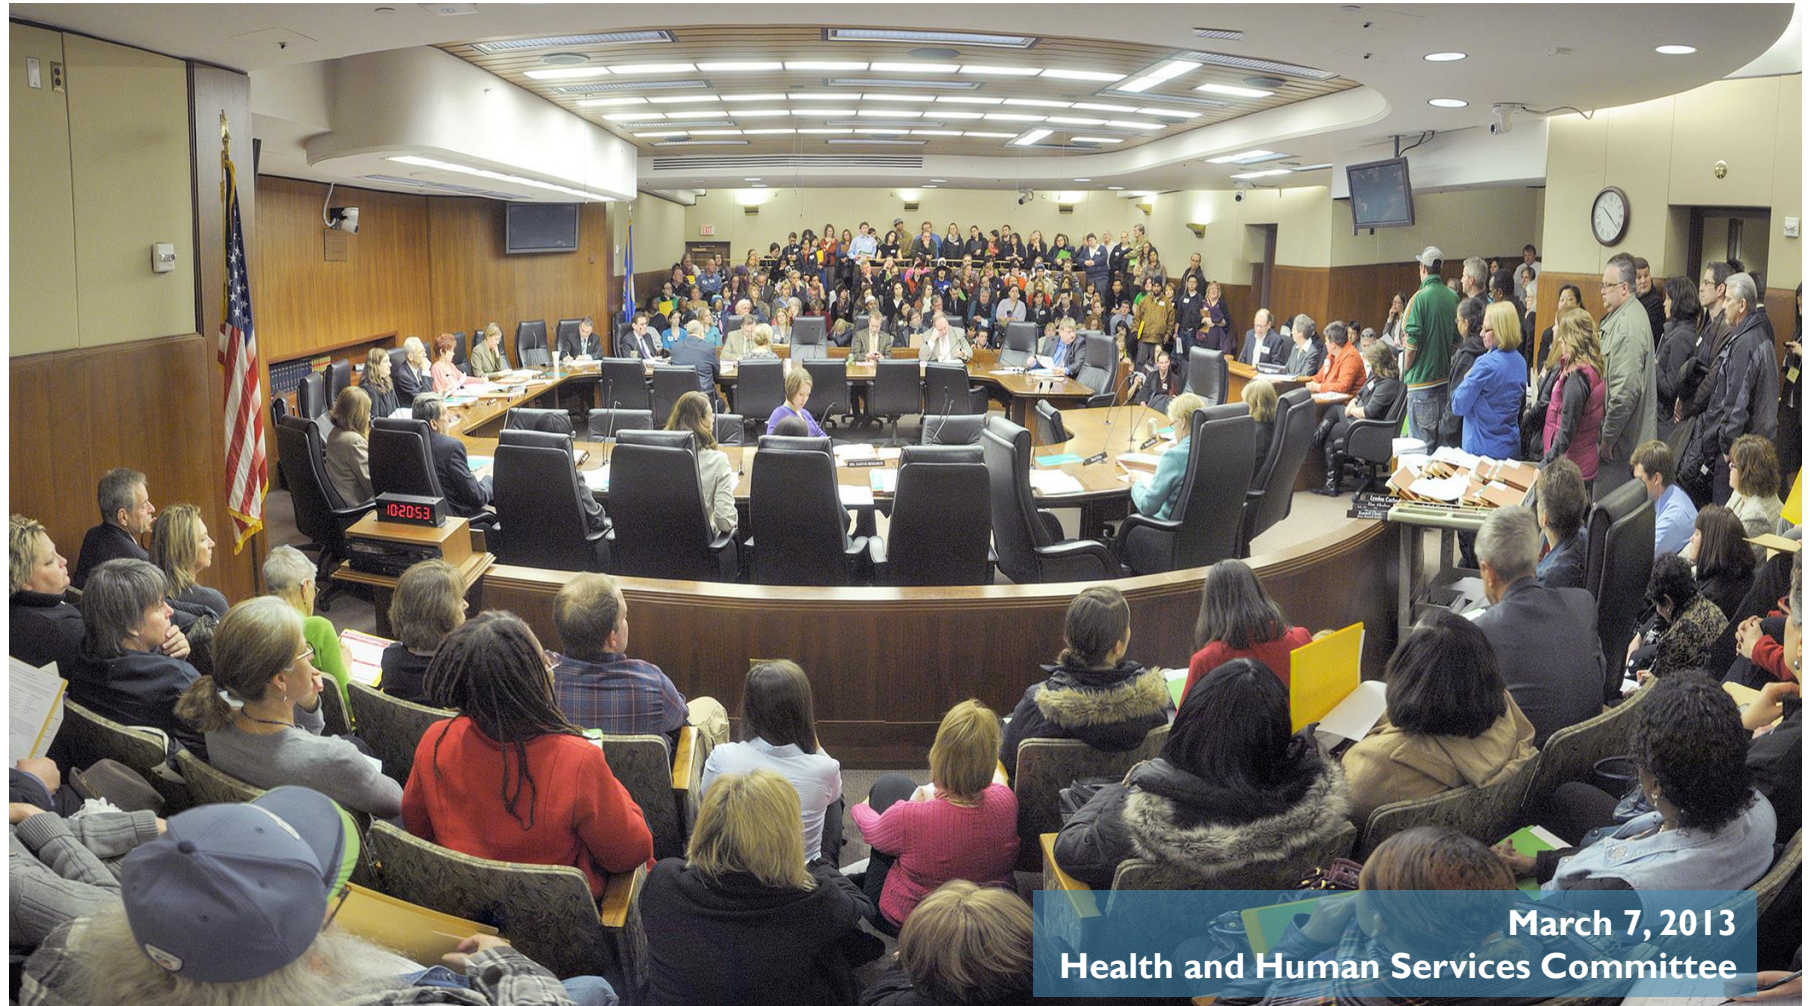
March 7, 2013
Health and Human Services Committee

Exit pathways blocked for members and audience by people standing in doorways, seated on stairs, and blocking emergency exits.

Members and staff do not have direct access to or egress from the hearing table.

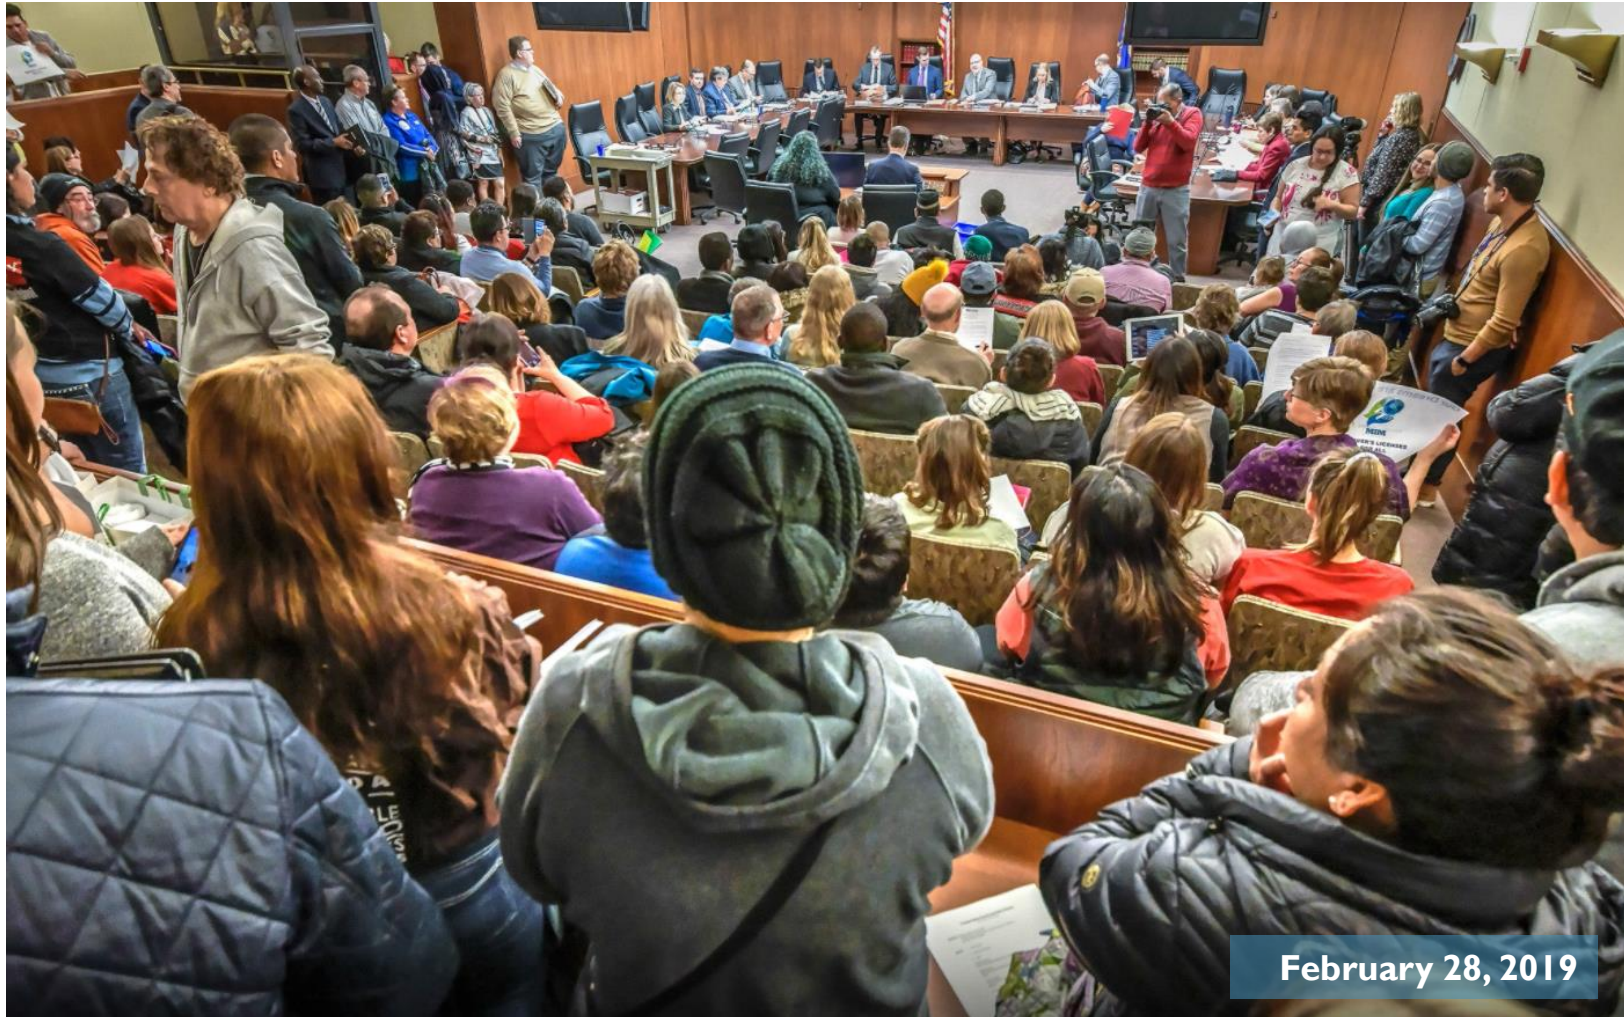
February 28, 2019

Exit pathways blocked for members and audience.

Members and staff do not have direct access to or egress from the hearing table.

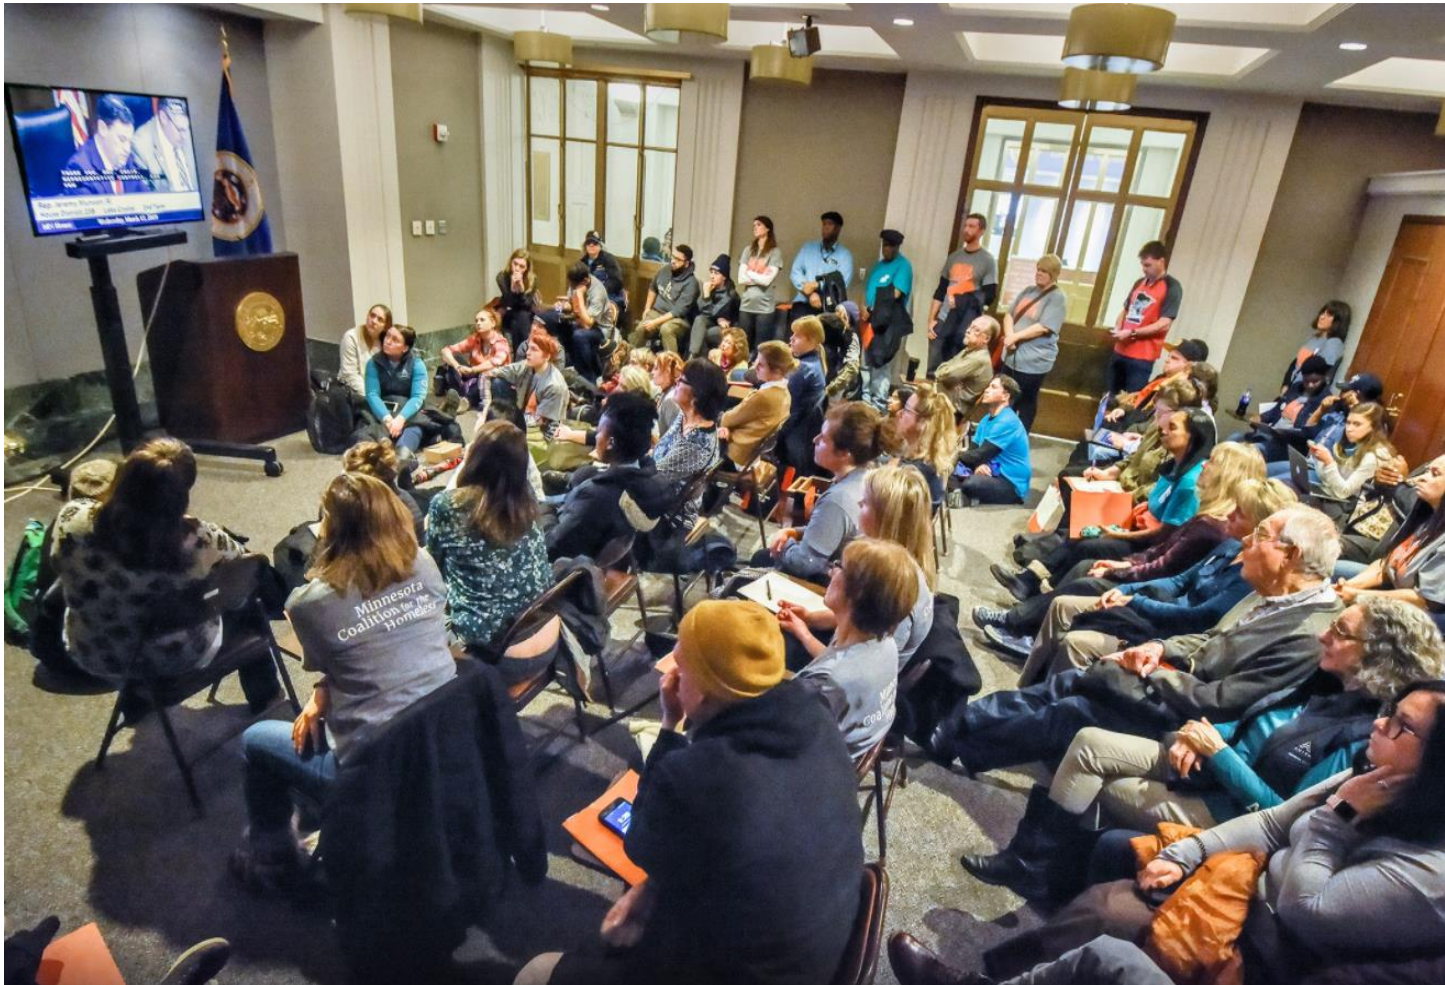
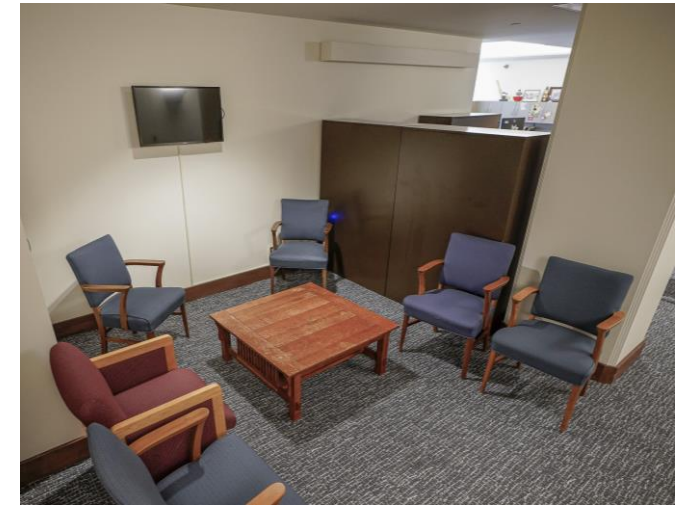
‘OVERFLOW’ AREAS

Hearing rooms regularly cannot accommodate all groups or individuals who arrive at the building for high interest hearings.

Available spaces are used as 'overflow seating', without convenient access for public testifiers, access to meeting materials, and poor viewing quality.

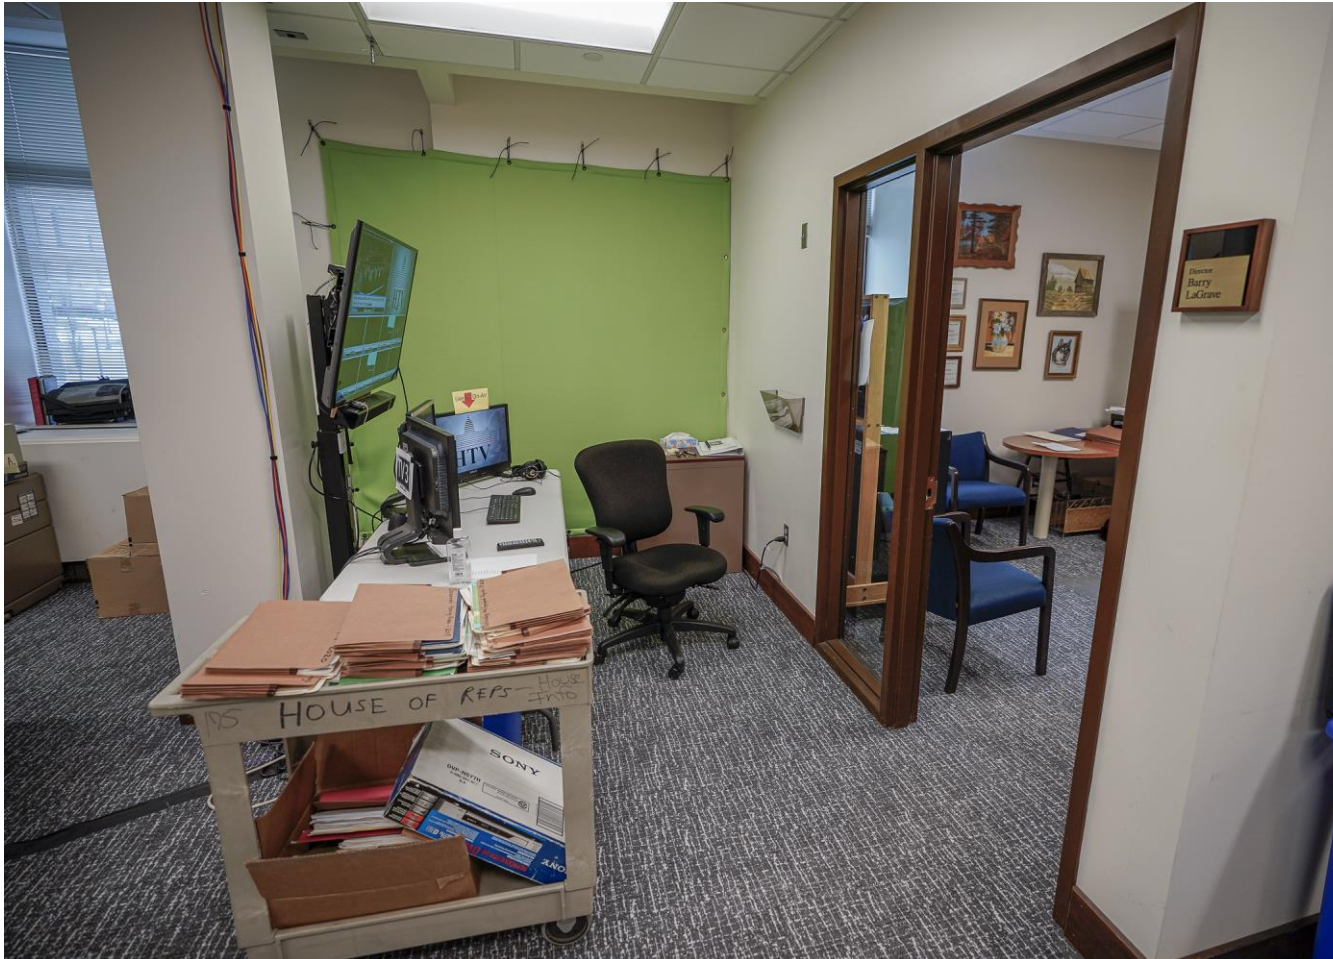
A television production area for broadcast content situated inside an open work area without visual or sound barriers.
