# Keeping our Streams Connected

## Culverts and Stream Health

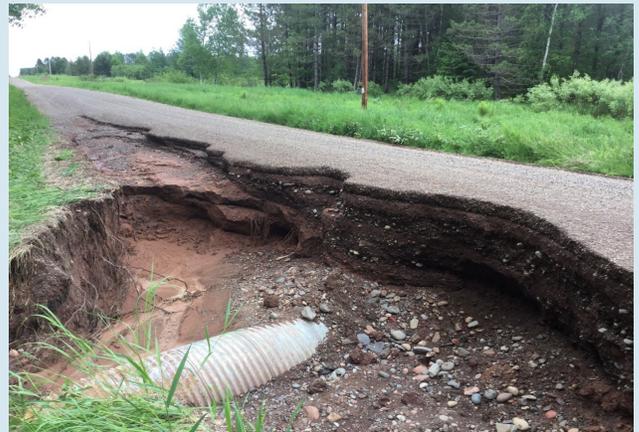
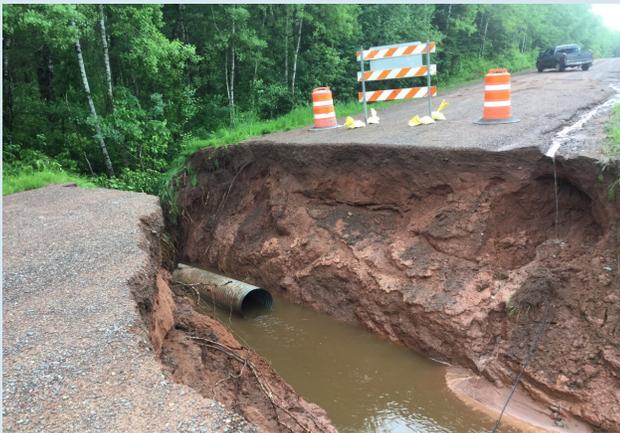
**Improved Safety** - Culverts that fail during storm events present a safety hazard. Drivers may be unaware of a washed out road and many flood deaths occur because people attempt to cross a flooded roadway. When roads are closed due to flood events, it can take much longer for emergency personal to assist with medical and fire emergencies.

**Water Quality** - When culverts fail or streams and rivers wash out a road, several tons of road material are washed down stream. This material not only becomes a major source of sediment throughout the watershed but also covers up stream and wetland plants. Valuable wetlands and wildlife habitat may be lost. Properly sized culverts help us keep the road and road materials where it's supposed to be....on the road!

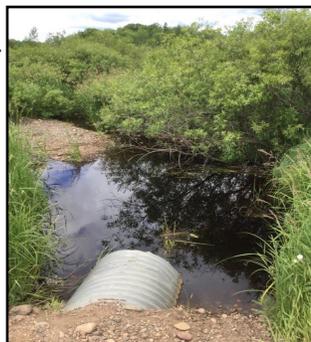
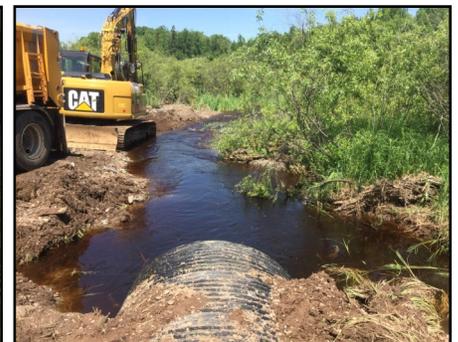
### Did You Know?

This culvert on CSAH 13 has washed out 3 of the last 5 years! After the 2018 flood, the 30" pipe was replaced with a 72" Pipe Arch Culvert with a natural bottom. At the same time, 5 truck loads of road material and gravel were removed from the stream and adjacent wetland. The cost of replacing the undersized culvert with an appropriate sized culvert cost \$3800 less than repairing damage from the flood.

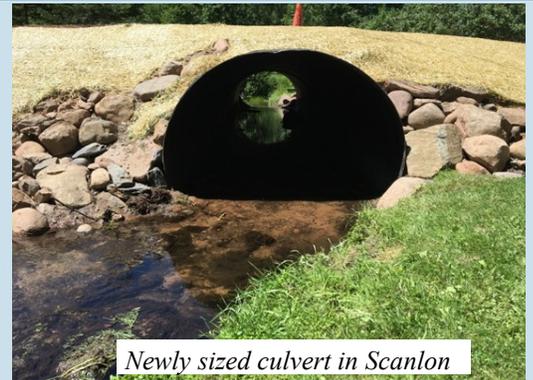
Bed material in the culvert helps reduce the energy of the water, reduces the wear on the culvert bottom, maintains the culvert elevations, and provides wildlife habitat. In some cases, a flood plain culvert that only flows during very high water may be added, so the stream will have access to the floodplain during a flood event. The bottom line is that a fish friendly culvert will look similar to the stream as it passes under the road.

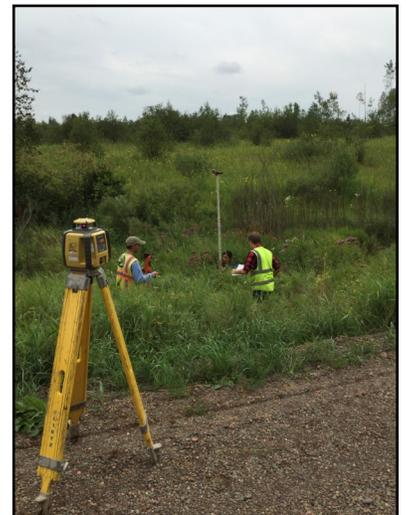
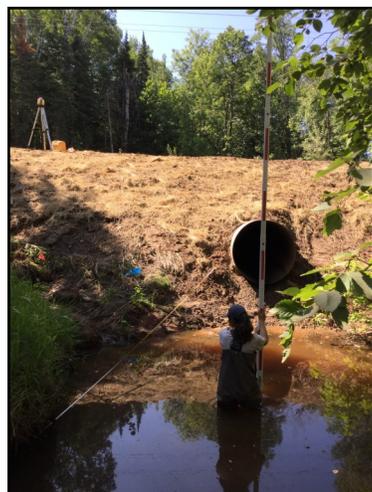
In 2017, the Carlton County Transportation Department and Carlton SWCD piloted a culvert inventory on all county maintained roads. The goal of this project was to evaluate the location, condition and biological/water quality impact of every culvert.

In 2018, the inventory was used after a 500 year flood washed away many culverts in the southern portion of the county. Pre-storm measurements were used to replace culverts that better matched the stream where possible. It was noted that culverts sized to the stream survived the flood with little damage and prevented the waters from overtopping the road. This saved money in costly repairs and allowed county residents to continue using the roads after the flood.
